Escape to Failure: The Qantas Flight 32 Uncontained Engine Failure

Steve Lilley

05/12/2015

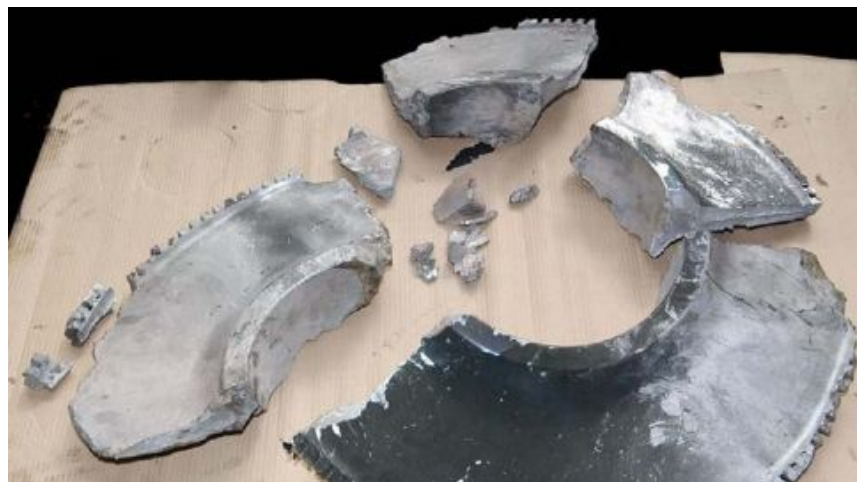
- The Australian Transportation Safety Bureau (ATSB) determined that the No. 2 engine sustained an uncontained turbine failure and that liberated engine components damaged the aircraft.
- A fatigue crack in the HP/IP oil feed stub pipe allowed oil to leak into a high temperature buffer space and ignite; fire damaged engine integrity. The IP turbine disc separated from the shaft, accelerated, and burst outward in three main pieces, breaching the casing and damaging the aircraft.

Figure 3. A Trent 900 IP turbine disc after an overspeed burst test. Source: Rolls-Royce plc./ATSB

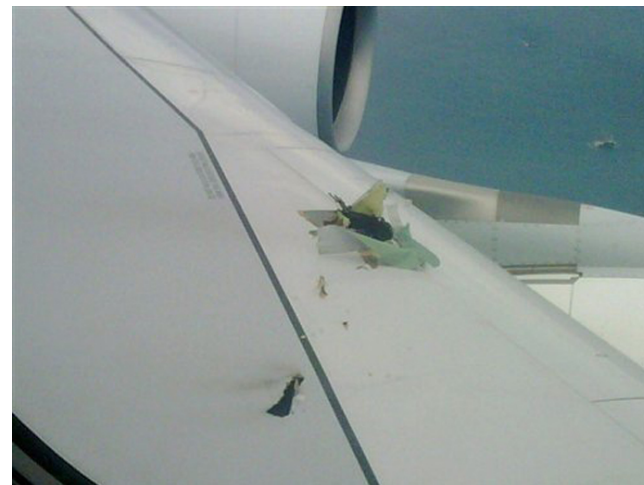
Figure 4. Damaged wing on Flight 32. Source: ATSB

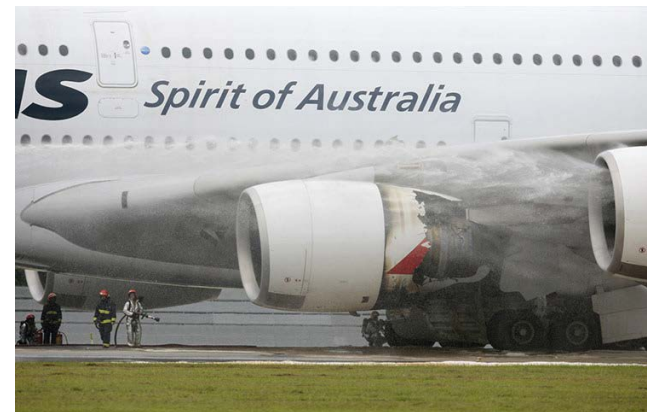
- At 11:46 a.m., Flight 32 touched down 95 tons overweight and rolled to a stop approx. 500 ft from the end of the runway.
- Fuel spilled onto the tarmac from the port wing as brakes cooled from 1,650 °F. Firefighters doused tarmac with retardant. Engine No. 1 could not be shut down and was drowned by shooting foam into the intake for 3 hours. No injuries were reported.

Figure 5: Drowning engine No. 1. Source: ATSB
